October 22, 2014

Subject: **Report of Limited Asbestos and Lead-Based Paint Survey**  
625 North Broadway Former Sanitary Laundry Facility  
750 Stone Street – Auto Repair Building  
760 Stone Street – Boiler House  
Knoxville, Tennessee  
EPA Cooperative Agreement Number BF-95443509-1  
S&ME Project No. 1434-11-392-007

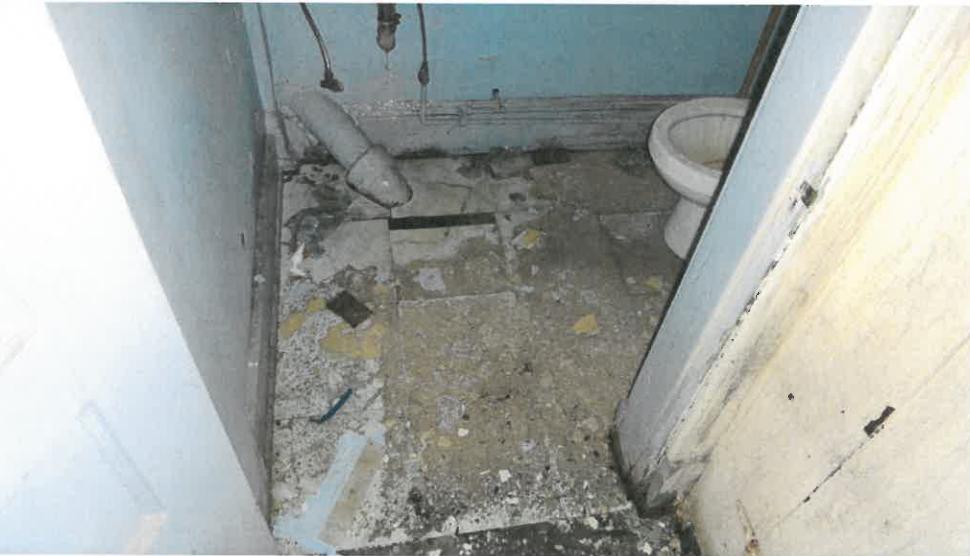
**Photo 1**

**Sample # / Location** SL-004 A/B / Sanitary laundry building - Ground floor bathroom room 103**Remarks** Beige square patterned linoleum with black mastic  
Linoleum: ND; Mastic 3% Chrysotile**Photo 2**

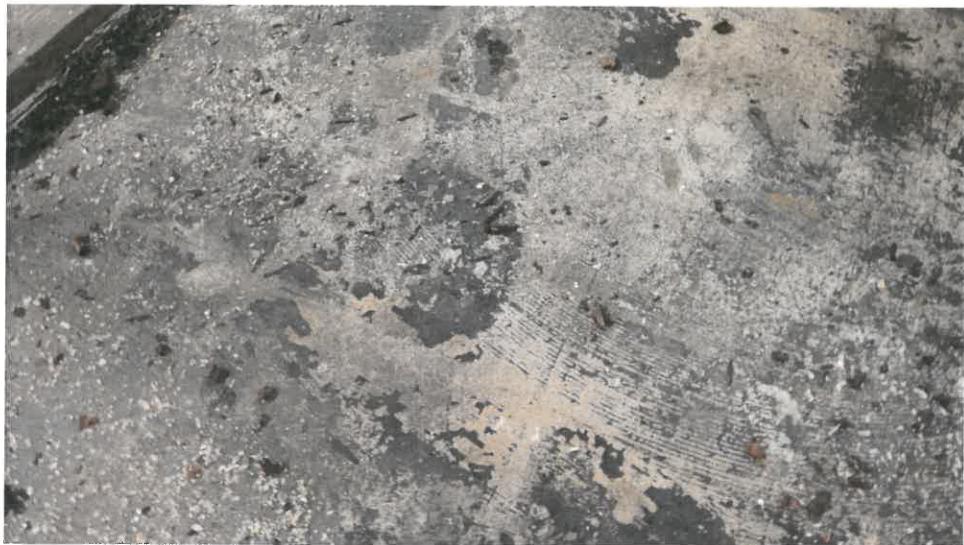
**Sample # / Location** SL-005 A/B / Sanitary laundry building - Ground floor room 101**Remarks** Black mastic on concrete floor  
7% Chrysotile

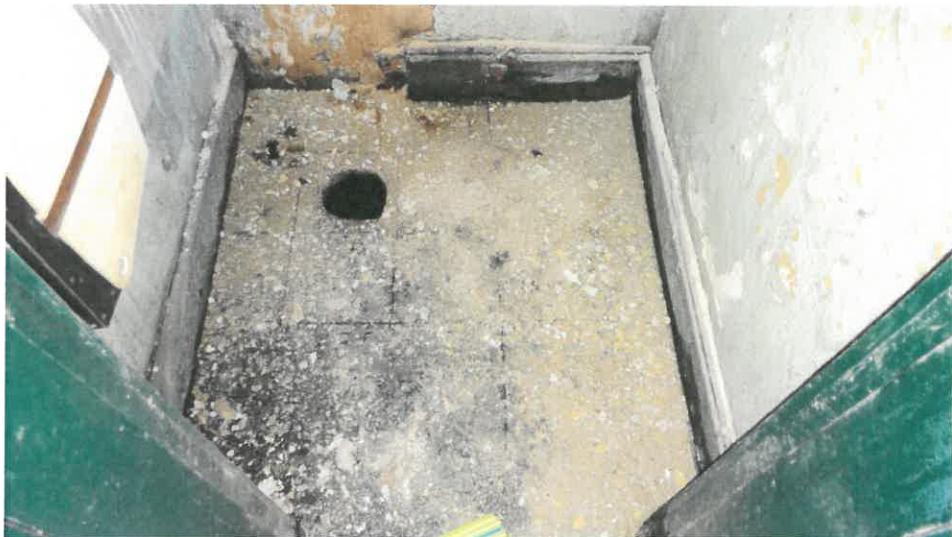
Photo 3

**Sample # / Location** SL-008 A/B/ Sanitary laundry building - Ground floor bathroom 102

Tile: 5% Chrysotile, Mastic: 3% Chrysotile

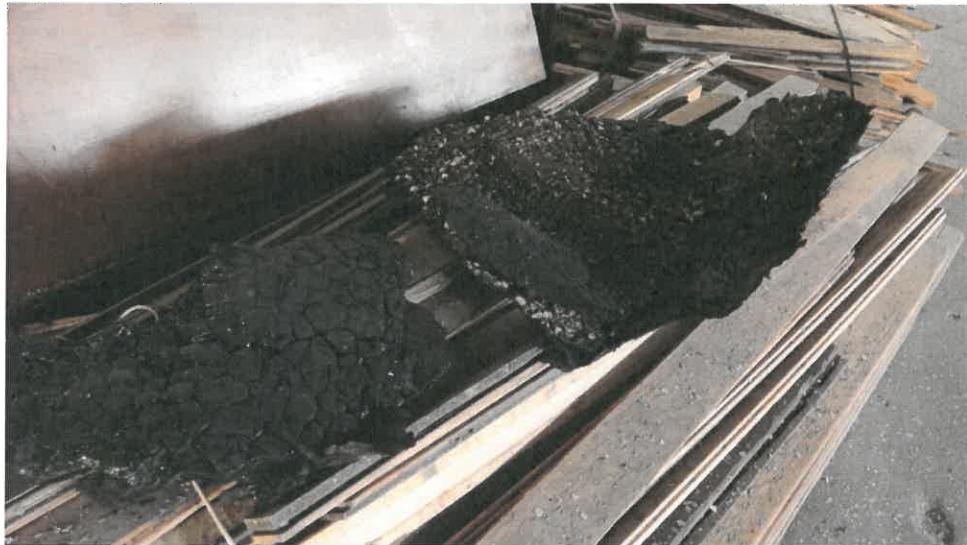
Photo 4

**Sample # / Location** SL-011 A/B & SL-012 A/B / Sanitary laundry building - Roof

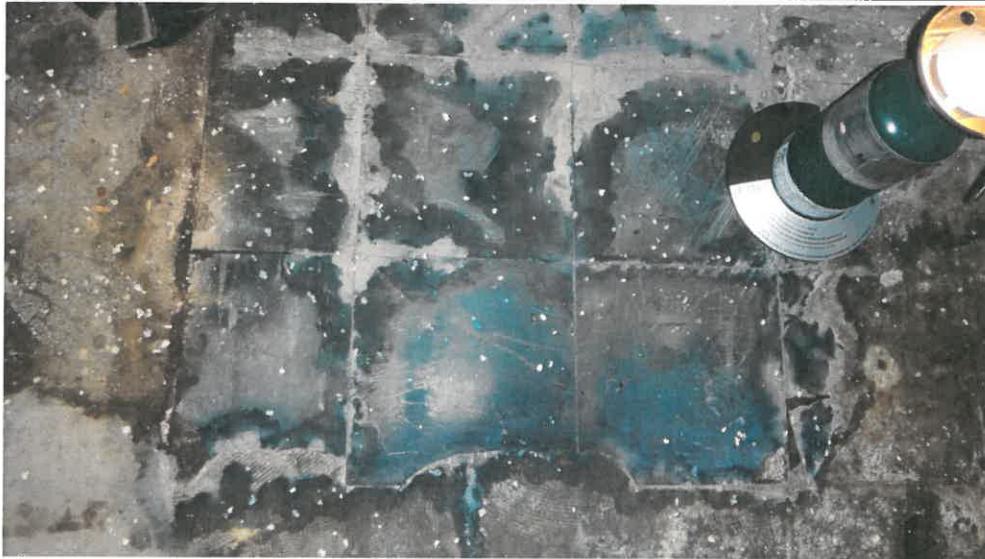
**Photo 5**

<b>Sample # / Location</b>	SL-018 A/B/ Sanitary laundry building - Basement room 010	<b>Photographer:</b> Emily Buckingham	<b>Date:</b> 2/19/2014
<b>Remarks</b>	Blue 9" x 9" floor tile with black mastic Floor tile: 4% Chrysotile, Mastic 3% Chrysotile

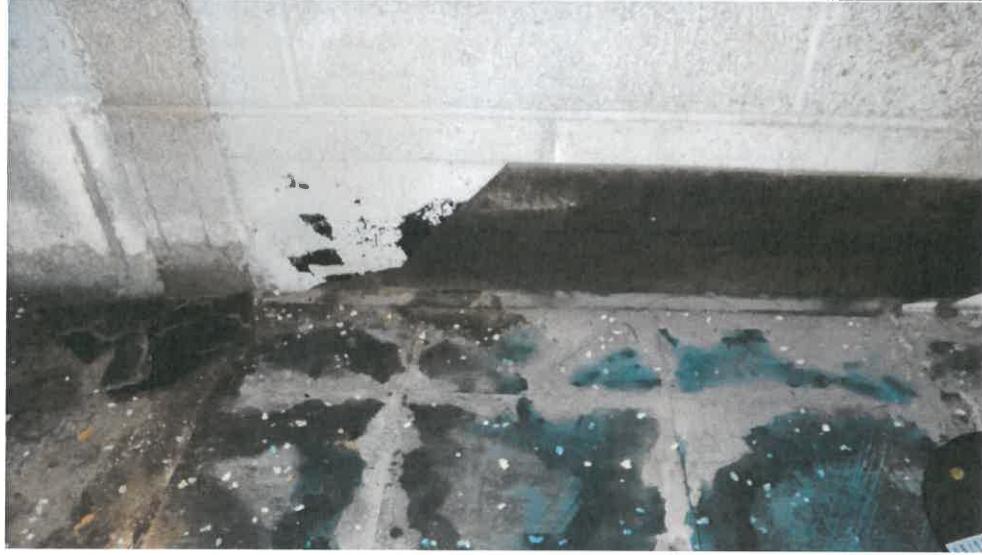
**Photo 6**

<b>Sample # / Location</b>	SL-019 A/B/ Sanitary laundry building - Basement room 010	<b>Photographer:</b> Emily Buckingham	<b>Date:</b> 2/19/2014
<b>Remarks</b>	Black covebase with black mastic Covebase: 4% Chrysotile, Mastic: ND

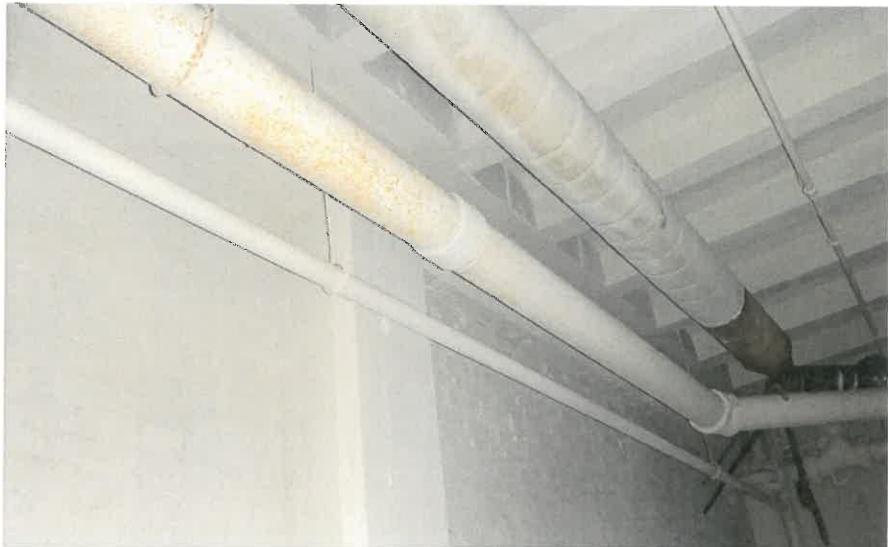
**Photo 7**

<b>Sample # / Location</b>	SL-020 A/B/C/ Sanitary laundry building - Basement rooms 009 and 010
<b>Remarks</b>	Brown paper and black tar layered thermal system insulation with paper wrap on water pipes Brown paper: 20% Chrysotile

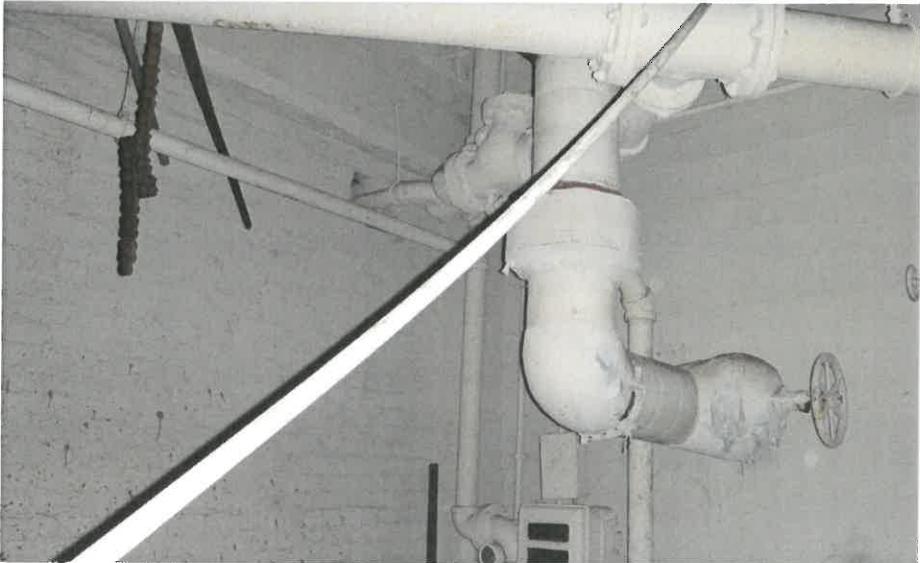
**Photo 8**

<b>Sample # / Location</b>	SL-021 A/B/C/Sanitary laundry building - Basement room 010
<b>Remarks</b>	Hard, White mud on elbows of water pipes 30% Chrysotile

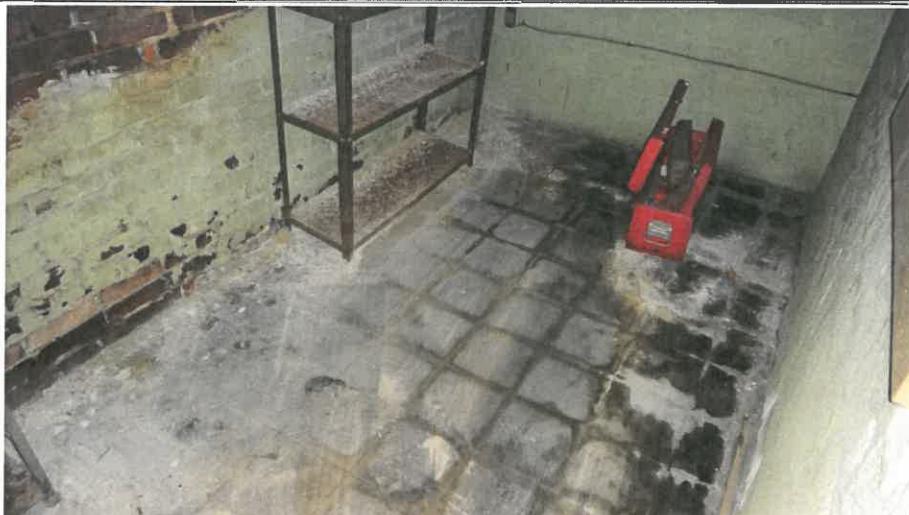
Photo 9

<b>Sample # / Location</b>	SL-022 A/B/Sanitary laundry building - Basement room 007
<b>Remarks</b>	Green 9" x 9" floor tile with black mastic Floor tile: 4% Chrysotile, Mastic 5% Chrysotile

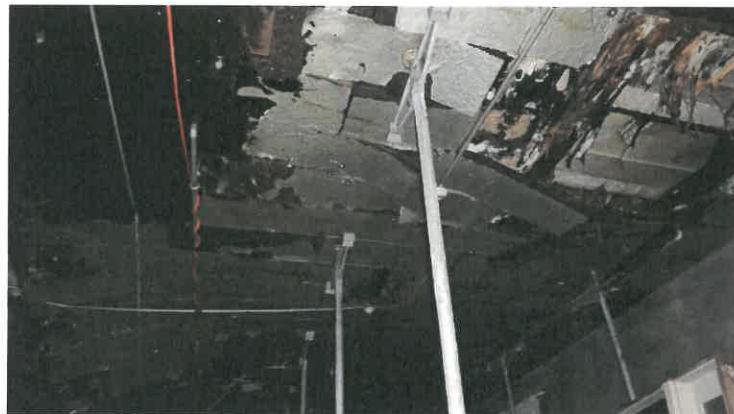
Photo 10

<b>Sample # / Location</b>	SL-024 A/B/ Sanitary laundry building - Basement room 015
<b>Remarks</b>	Silver paint over black mastic on corkboard on ceiling Black mastic: 2% Chrysotile
